Madder Lake Production

(MedColourTech Project – 2006-2009)

Test-Production of Madder Lake pigment, according to a historic recipe, mentioned in “Die Farbstoffe” by P. Schützenberger, 1873.

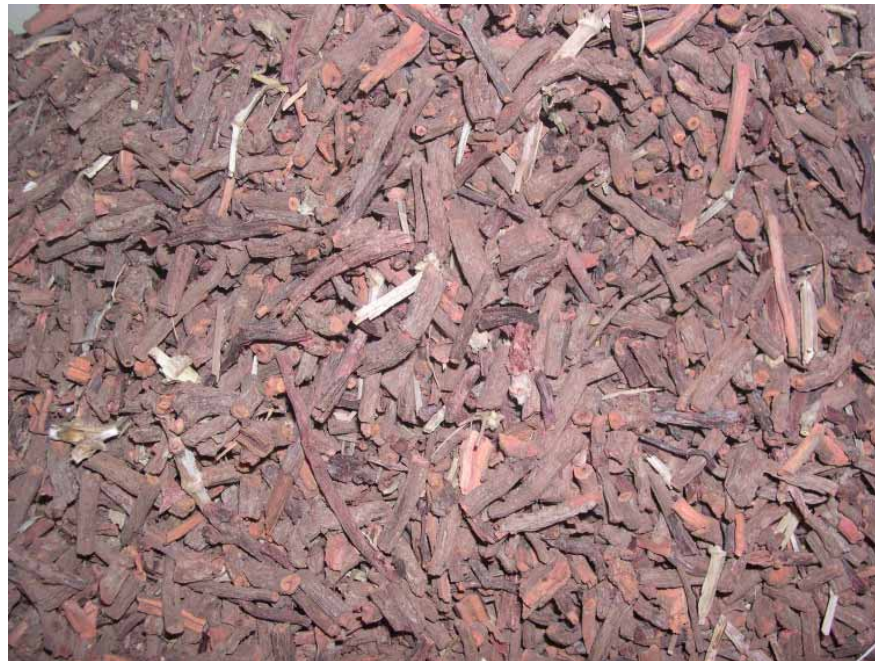
Turkish Madder Roots

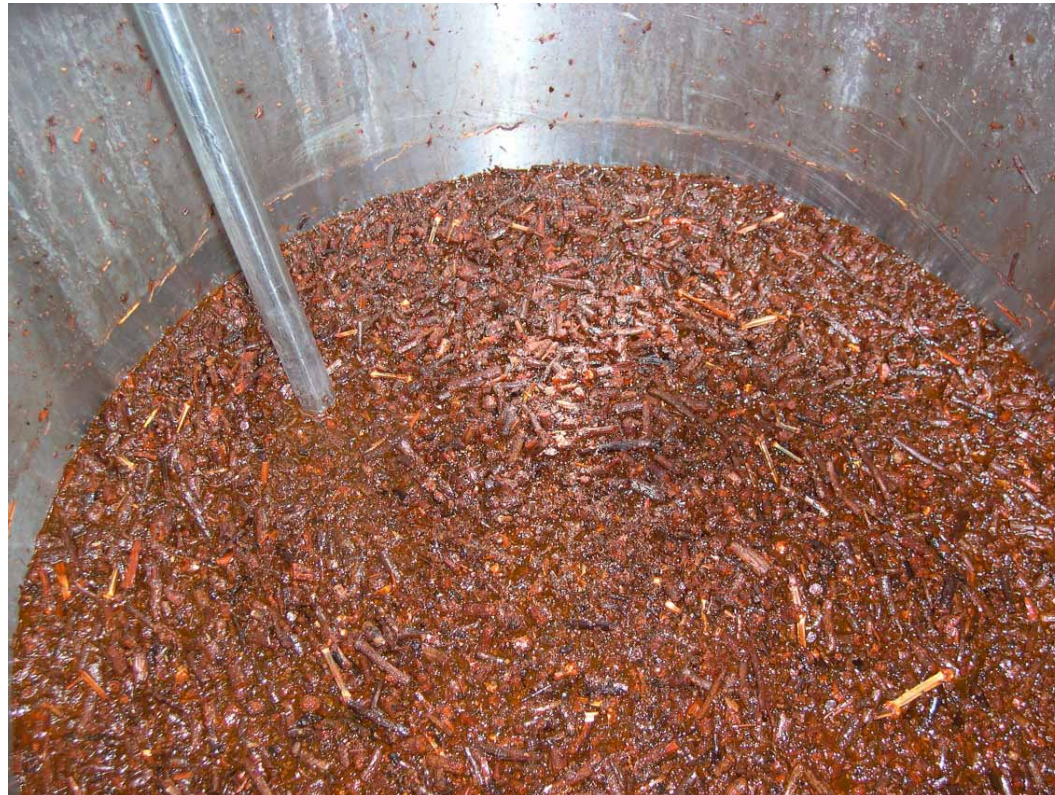
The shredded and washed madder roots are boiled in an alum solution...

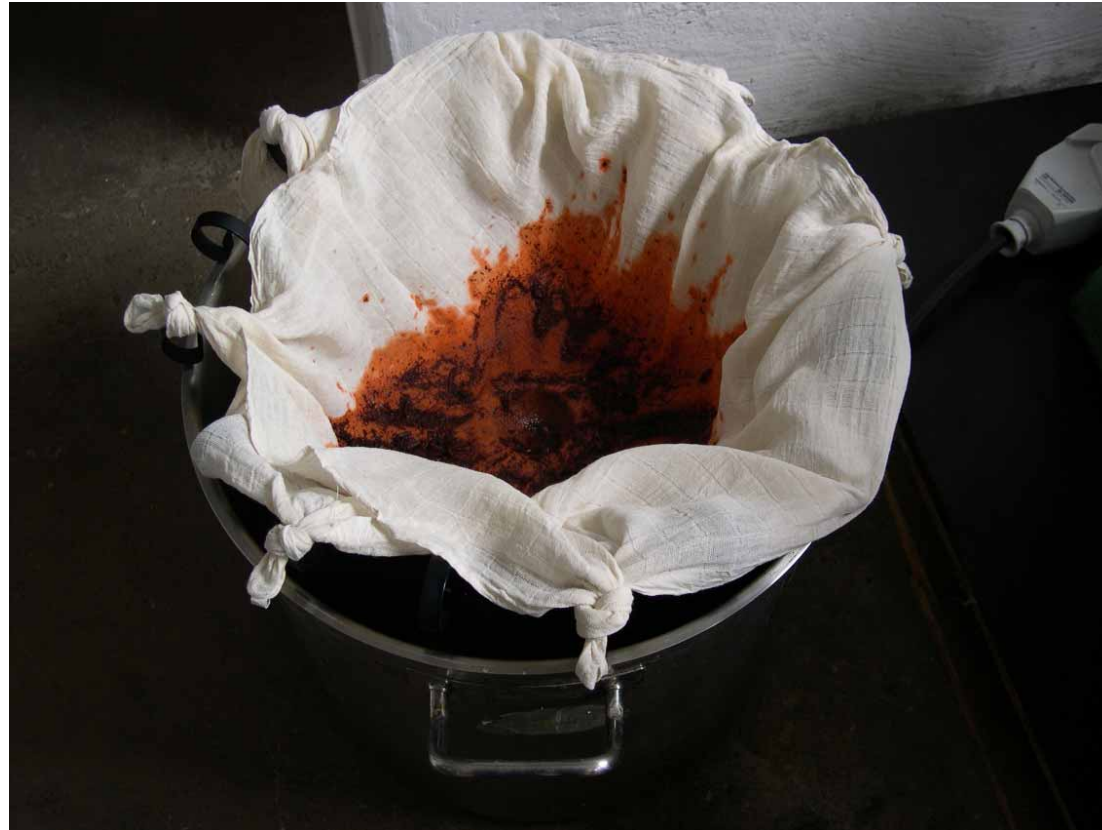
filtered...

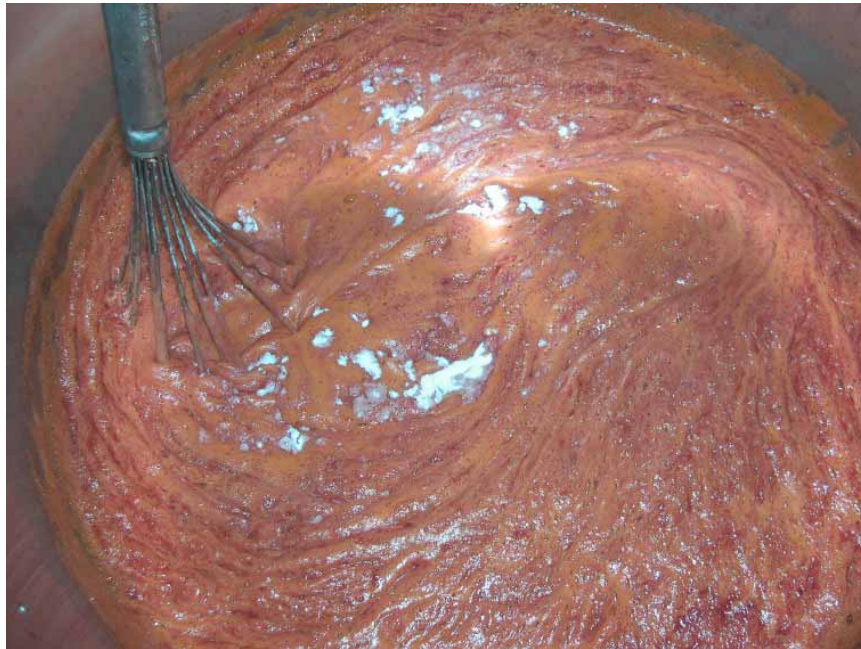
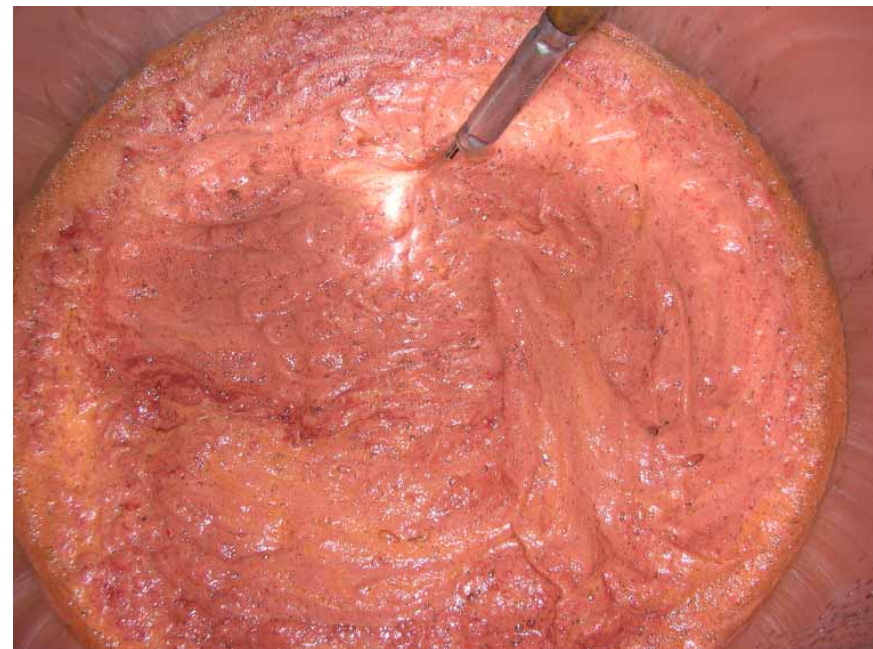
**sodium carbonate is added to the cold madder solution
and brought to boiling point**

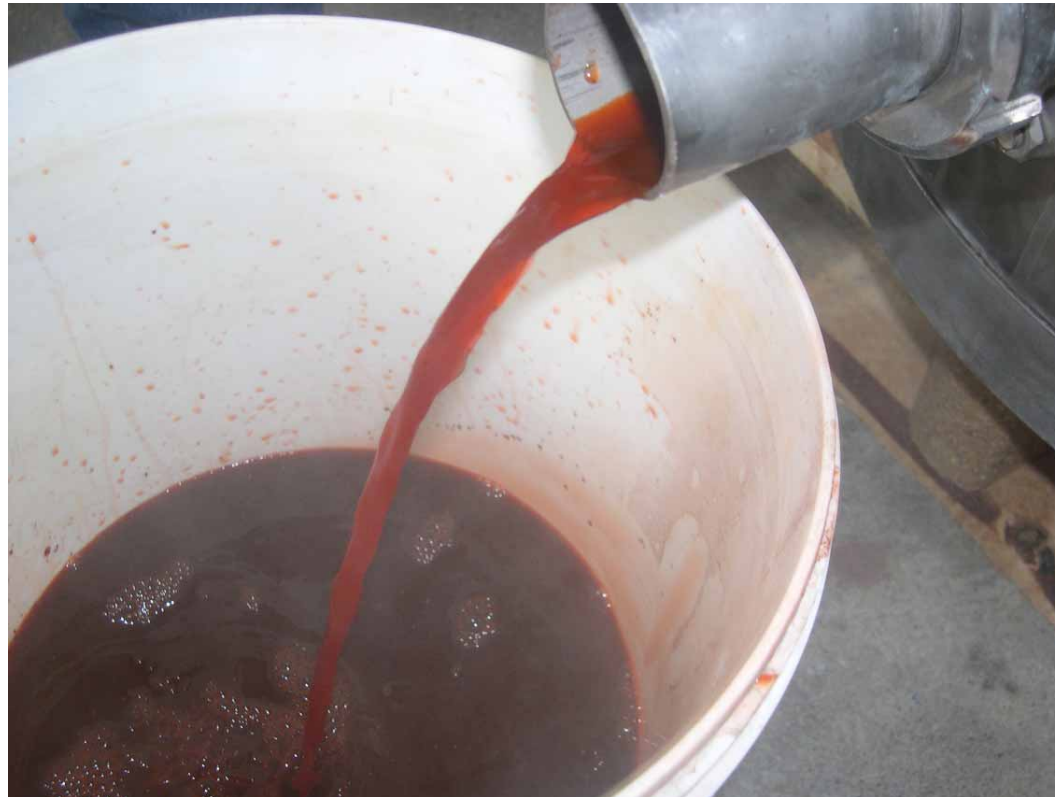
The hot liquid...

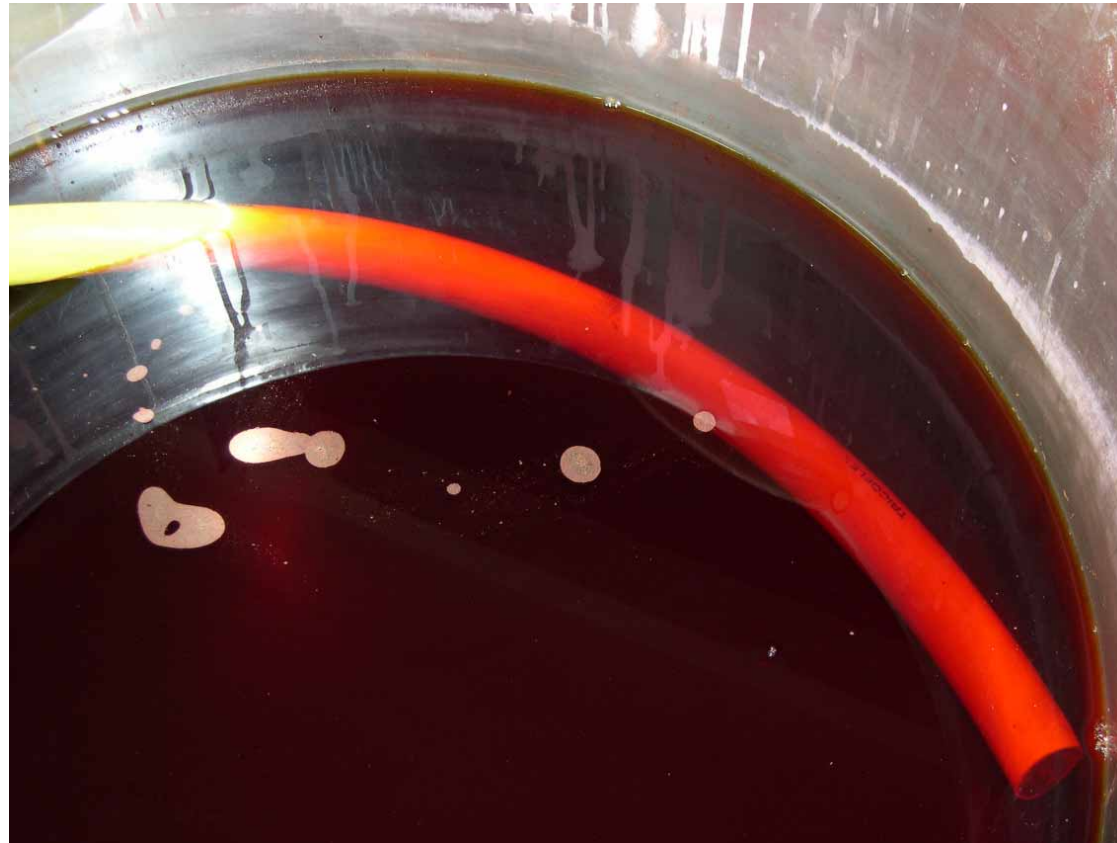
is left to cool down...

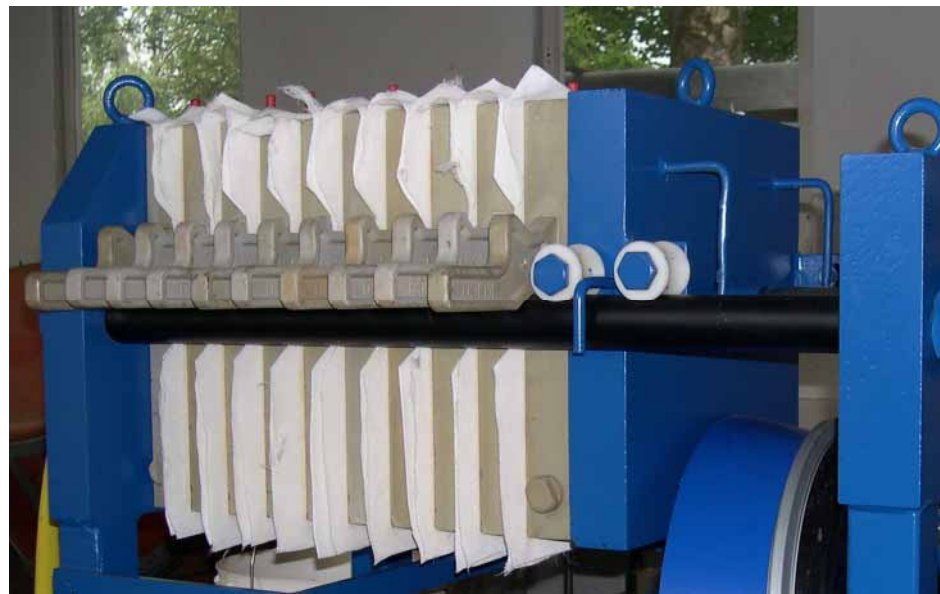
and pumped through a high pressure filter system.

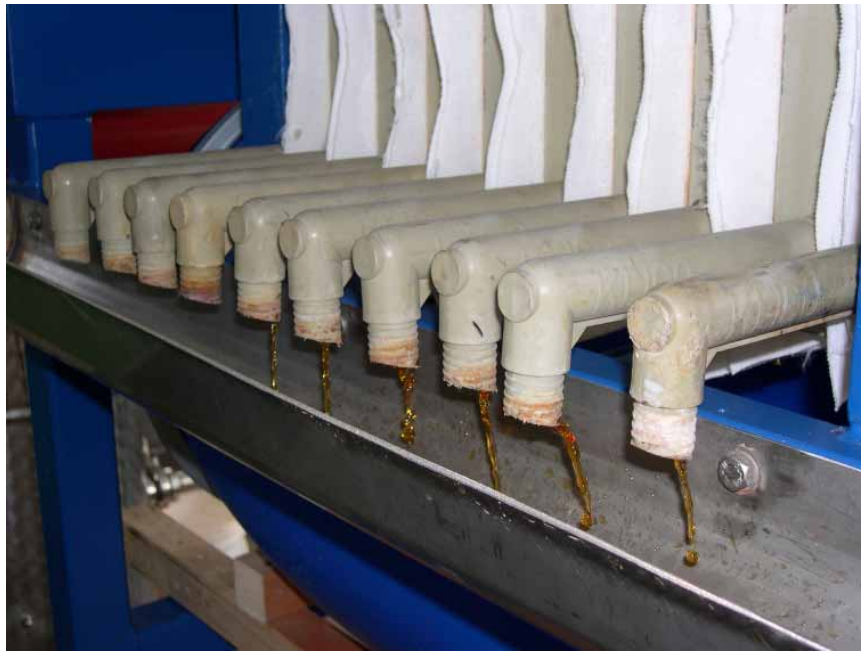
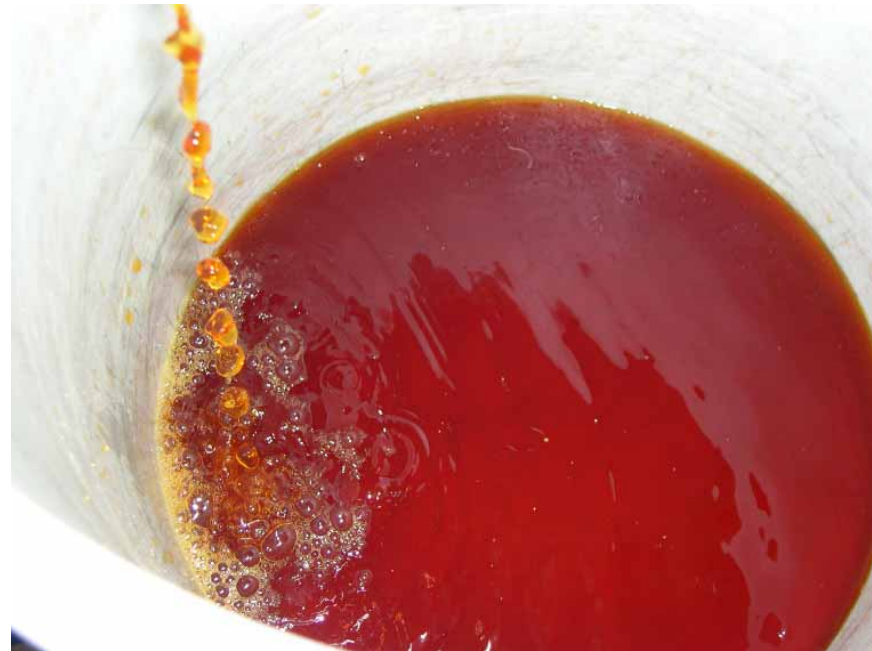
The extracted pigment stays in the filters, the filtered liquid is almost clear.

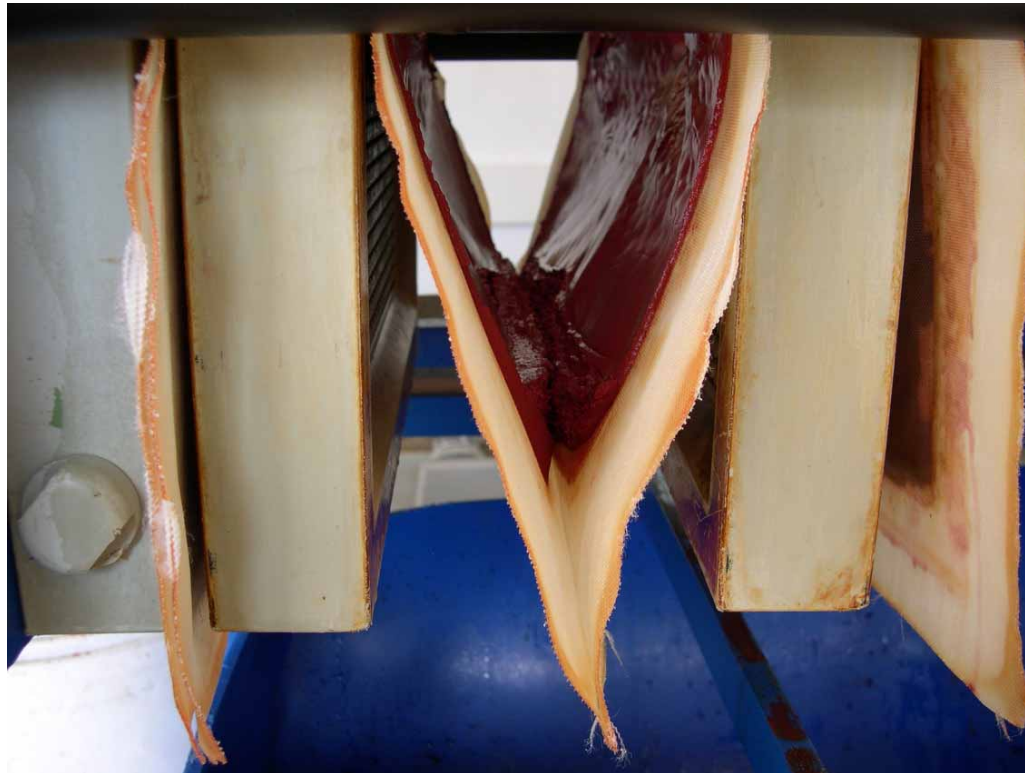
The filters are separated...

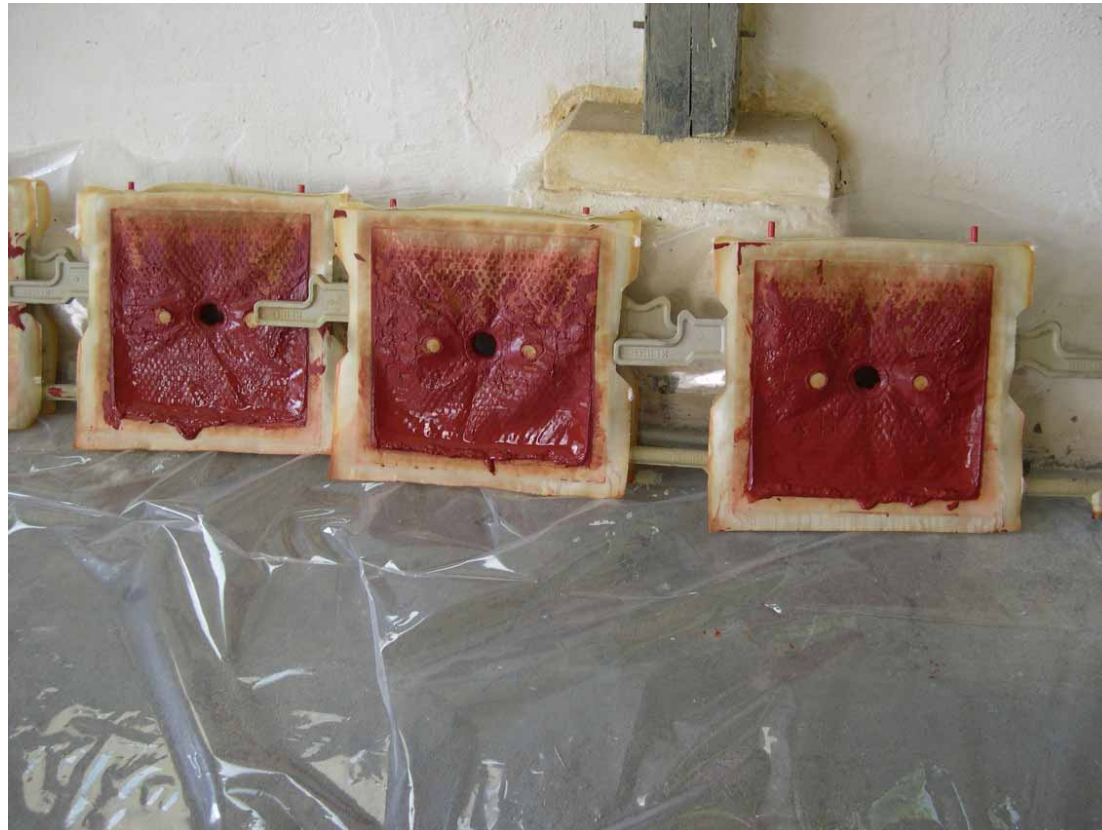
and left to dry.

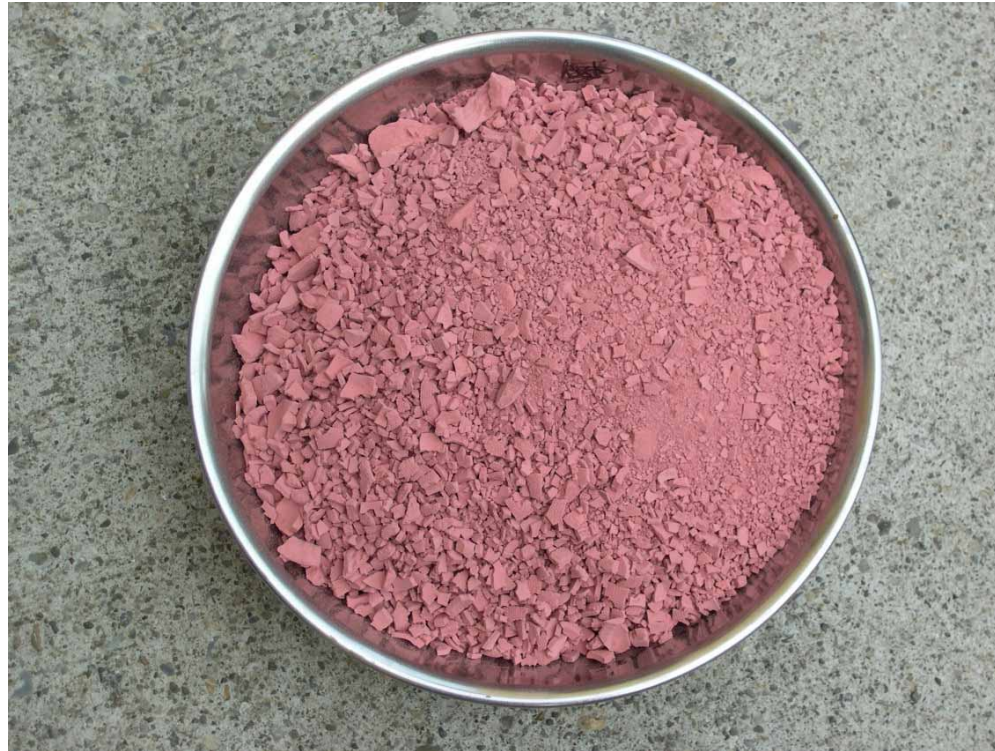
Unground dried madder lake.

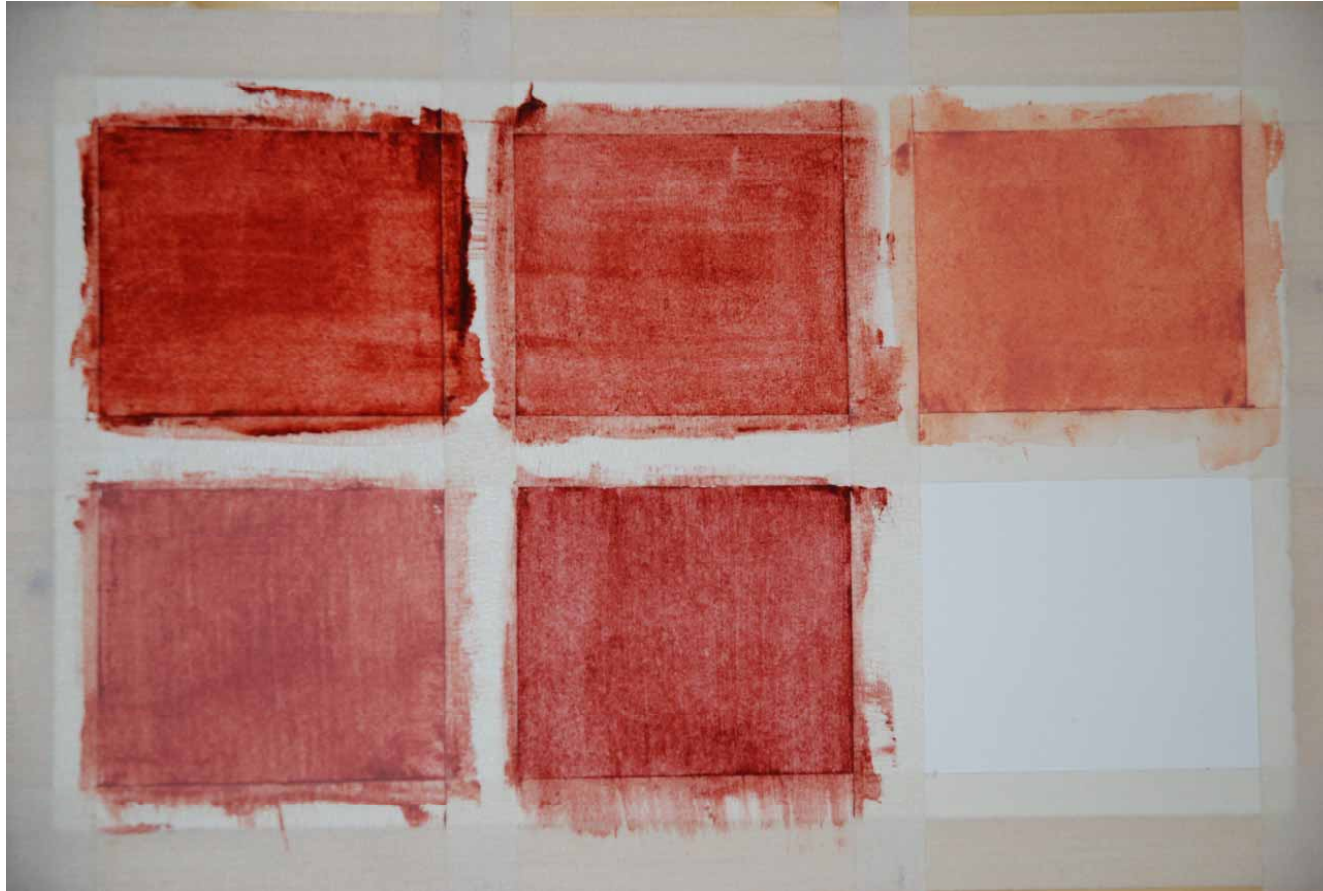
pigment ground in medium like gum arabic, painted on paper for lightfastness tests

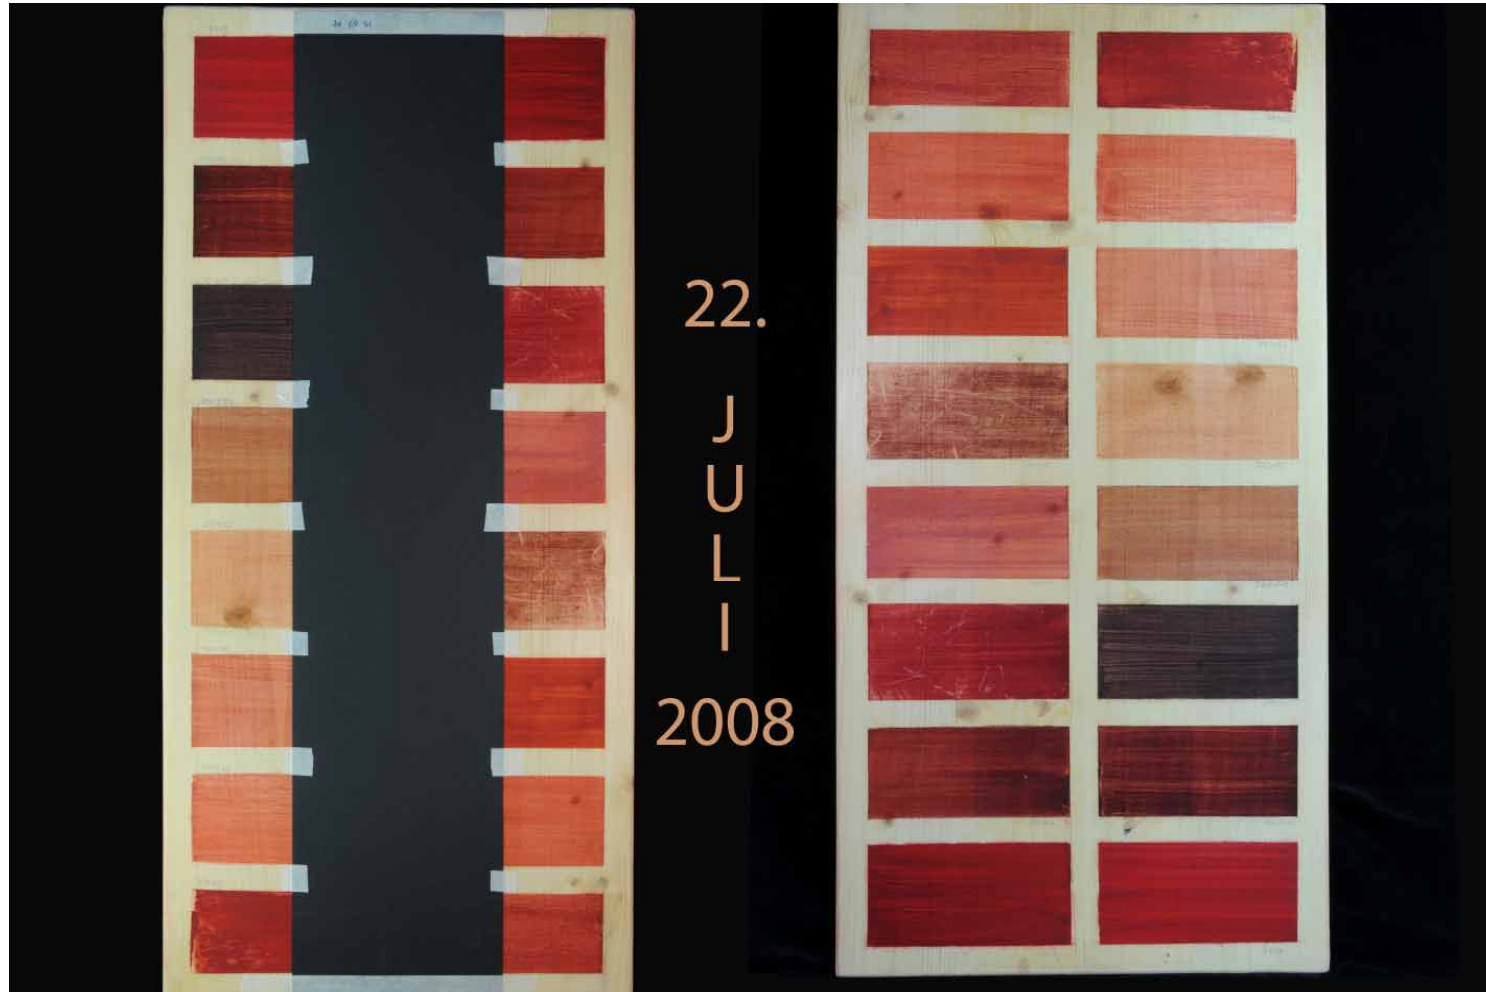
Lightfastness test

The Madder Lakes were ground in linseed oil and applied onto wood.
Half of the colors were covered with black paper, half of each color was exposed to sunlight.

On 29 September 2008 the following visual results could be recorded:
